# Manhole Inspection Summary

Manhole # S31AA1009MH

**Location** Address: **SAN MARTIN DR**

Cross Street: **JOHNS HOPKINS UNIV**

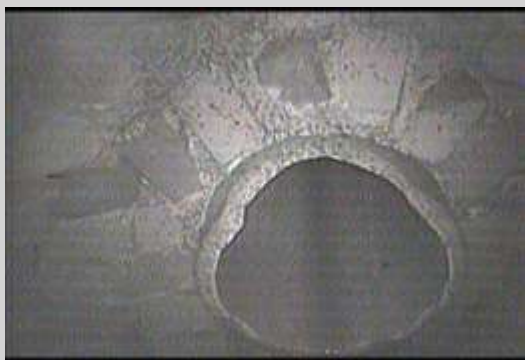
### 8 in. Circular Gravity Sewer Pipe In @ 4 O'Clock

Rod and Bar (Angled)

Infiltration: **None** Pipe Seal Cond: **Unknown**

Drop Condition: **Partly Clogged**
